PROCEEDINGS

AUGUST, 1953

STRUCTURAL OBSERVATIONS OF THE
KERN COUNTY EARTHQUAKE

by Henry J. Degenkolb

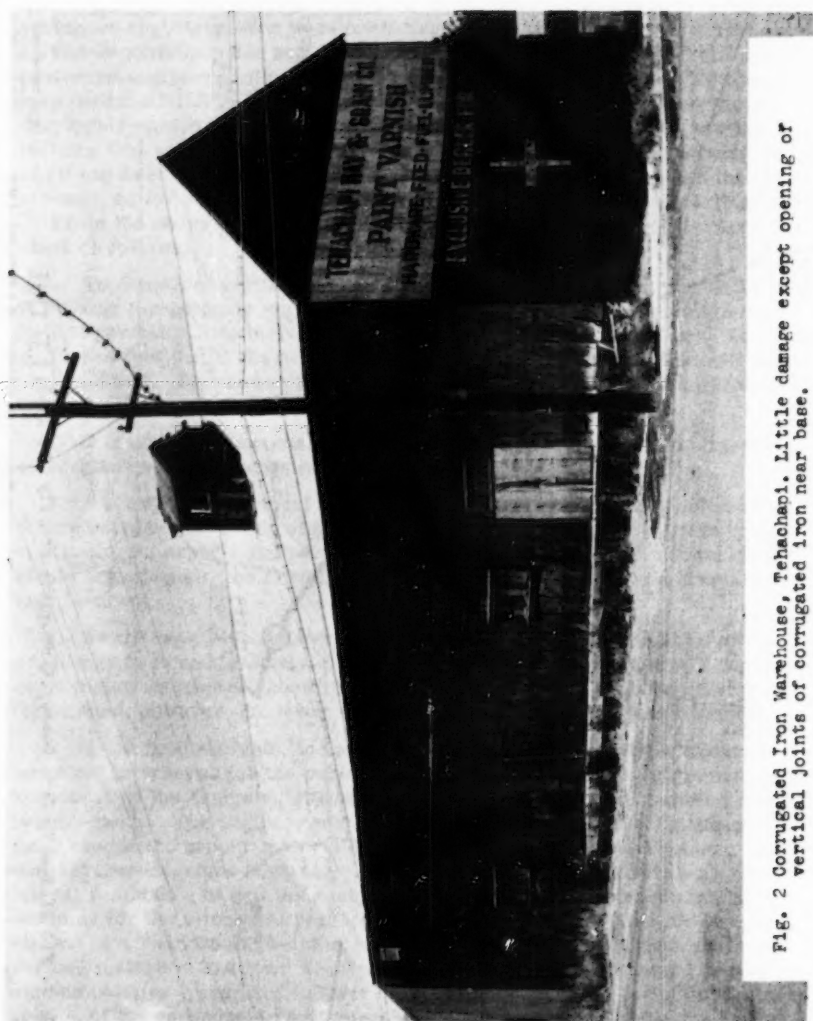
FIG. 2 Corrugated Iron Warehouse, Tehachapi. Little damage except opening of vertical joints of corrugated iron near base.

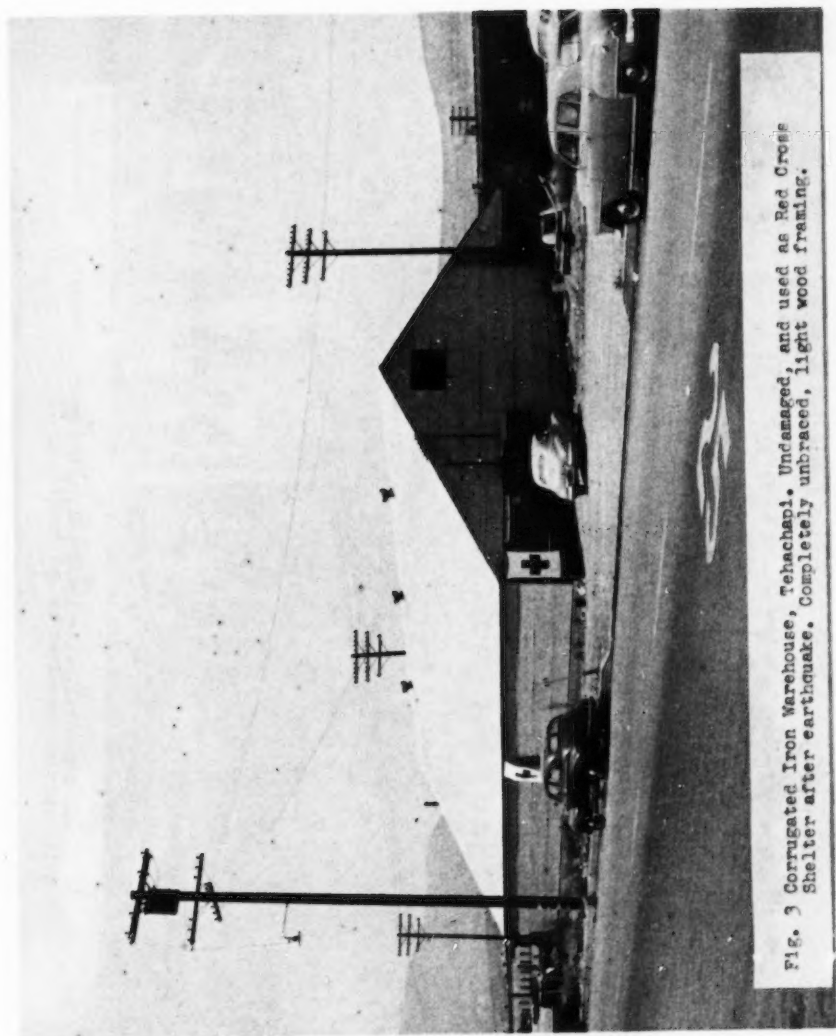
FIG. 3 Corrugated Iron Warehouse, Tehachani. Undamaged, and used as Red Cross Shelter after earthquake. Completely unbraced, light wood framing.

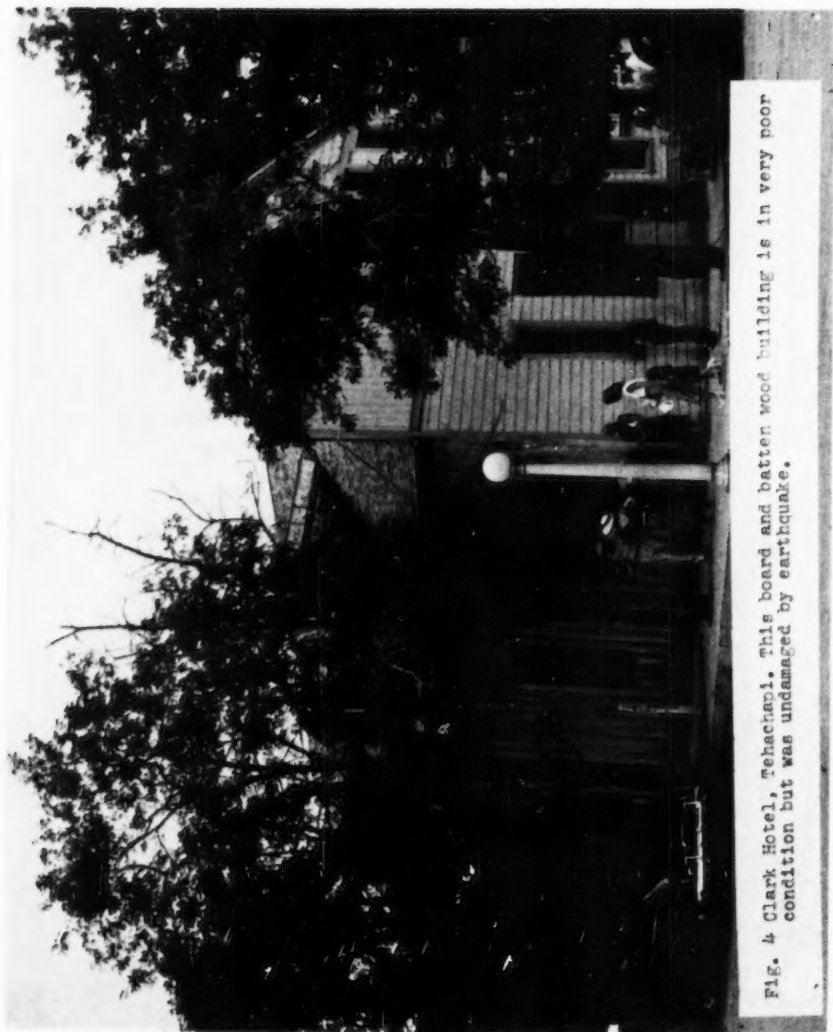
FIG. 4 Clark Hotel, Tehachapi. This board and batten wood building is in very poor condition but was undamaged by earthquake.

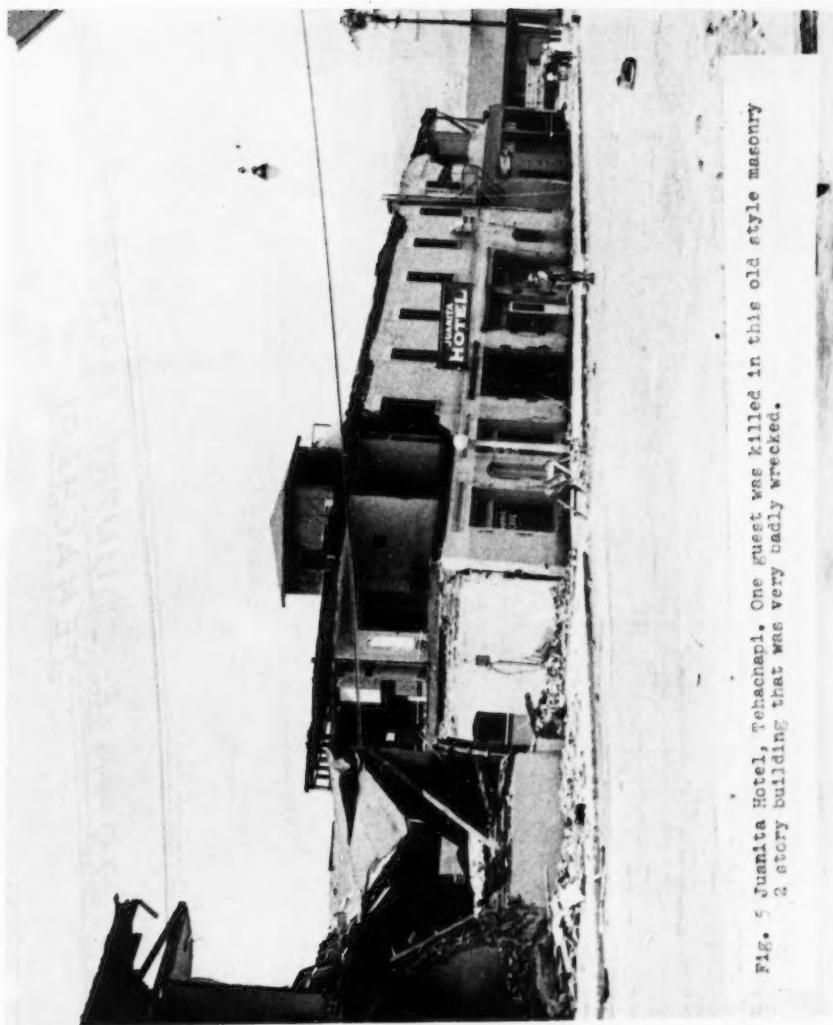
One approach to studying the performance of structures in an earthquake, is the relationship of their performance as compared to rigidity. Certain flexible structures performed very satisfactorily in this earthquake in spite of the fact that they had little or no bracing. Outstanding among this group of buildings are various timber buildings including warehouses, corrugated iron buildings with either wood or steel framing, and steel structures such as service stations (Figs. 2 and 3). It is interesting to speculate that the man who notified the outside world that Tehachapi had been leveled by the earthquake, may have phoned from an undamaged service station. The Clark Hotel (Fig. 4), an old frame board and batten building, was undamaged; although in the same block the Juanita Hotel (Fig. 5)—an old style masonry building—was badly wrecked killing one of its occupants.

Fig. 5 Juanita Hotel, Tehachapi. One guest was killed in this old style masonry 2 story building that was very badly wrecked.

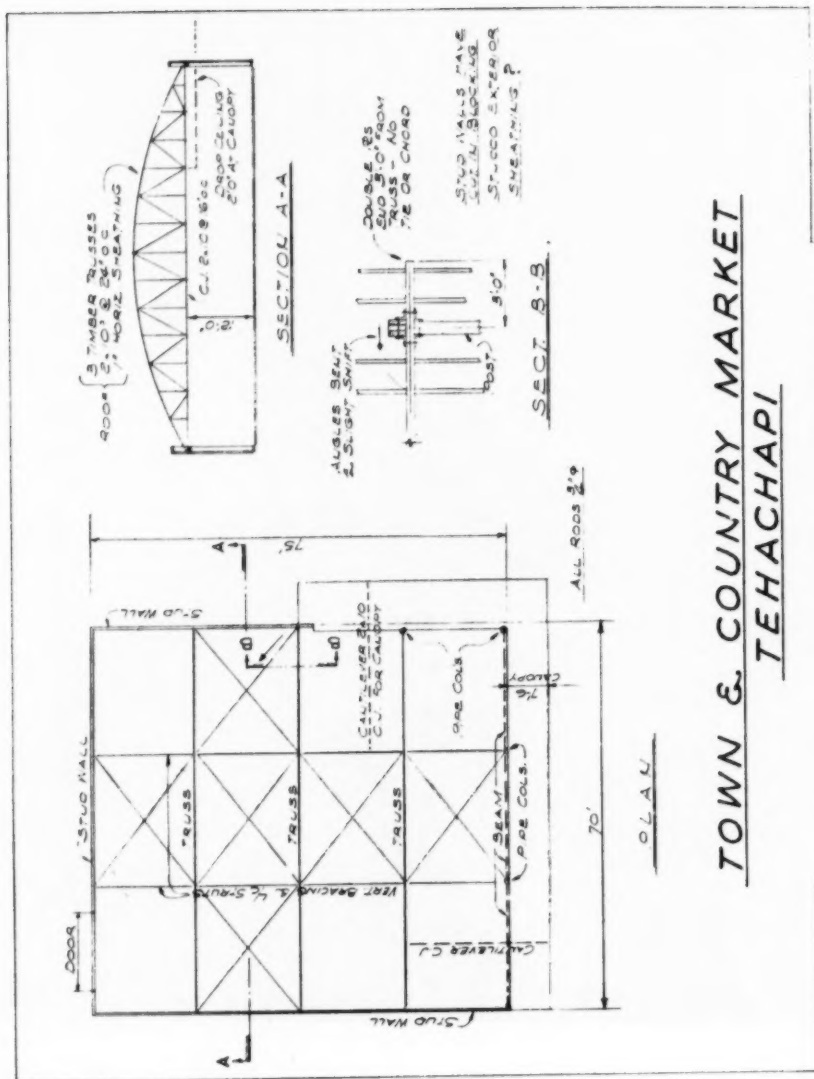
Fig. 6 Framing of Town and Country Market, Tehachapi.

The vast majority of the timber residences were undamaged. Frame structures of all kinds such as churches, schools, stores, etc., had only minor damage or no damage at all, even where there was no apparent lateral force design. The Town & Country Market (Fig. 6) is a wood frame and stucco building that lost its plate glass windows and had minor plaster cracks. Except for this, it can be said that the building was essentially undamaged. The store is 75' x 70' in plan with a 12'-0" ceiling height (Fig. 7). It uses 3 timber trusses with rod bracing at the lower chord and horizontal roof sheathing. When the truss manufacturer designed the rod bracing, he evidently assumed

that there would be resisting elements front and rear. However, there is no front resisting element because there are pipe columns and only simple connections to the beams and so there is considerable torsion on the building. As constructed, it can be figured to resist less than 6#/sq. ft. wind or about 5-1/2%G on dead load only. It is no wonder that the plate glass windows broke. However, in spite of the design deficiencies, the store was open for business shortly after the earthquake.

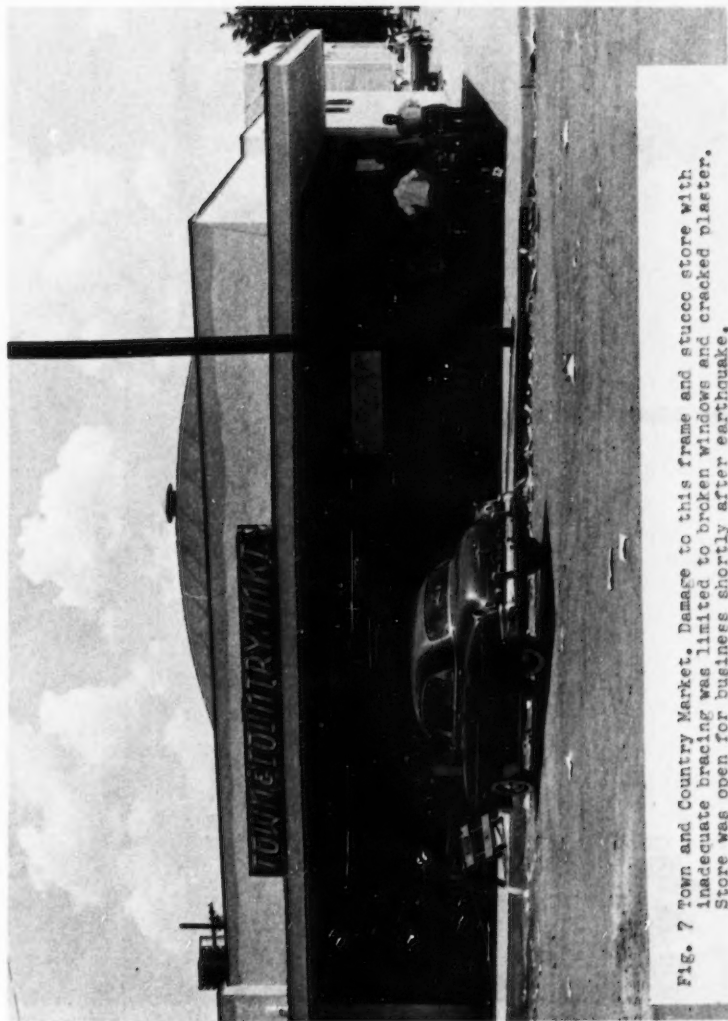
FIG. 7 Town and Country Market. Damage to this frame and stucco store with inadequate bracing was limited to broken windows and cracked plaster. Store was open for business shortly after earthquake.

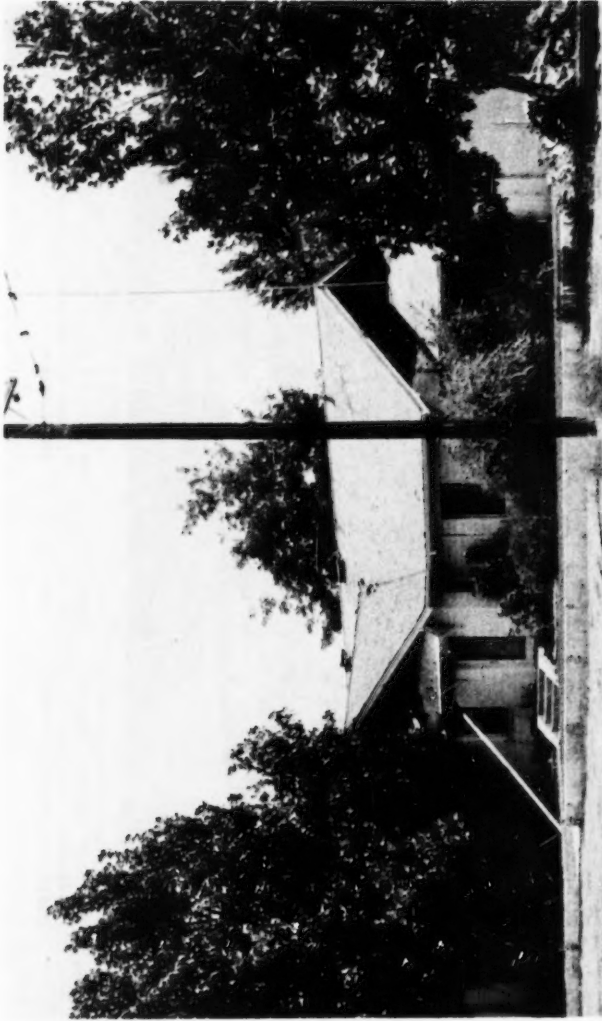
At the other extreme, we have the heavy, rigid, unreinforced masonry buildings which often suffer severe damage. Houses constructed of adobe with their heavy, weak materials were badly wrecked (Fig. 8). The Cummings Valley School (Fig. 9), built in 1910 of practically unreinforced concrete, was destroyed.

Fig. 3 Adobe House, Tehachapi. All adobe houses in Tehachapi were badly shattered.

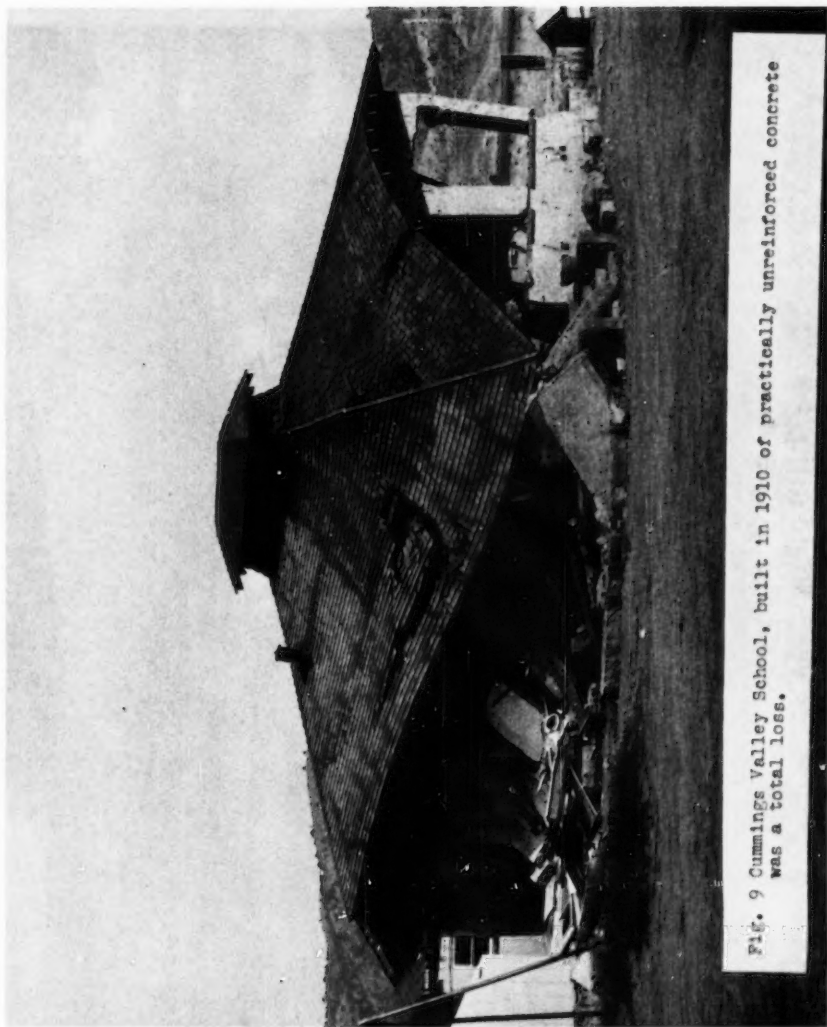
Fig. 9 Cummings Valley School, built in 1910 of practically unreinforced concrete was a total loss.

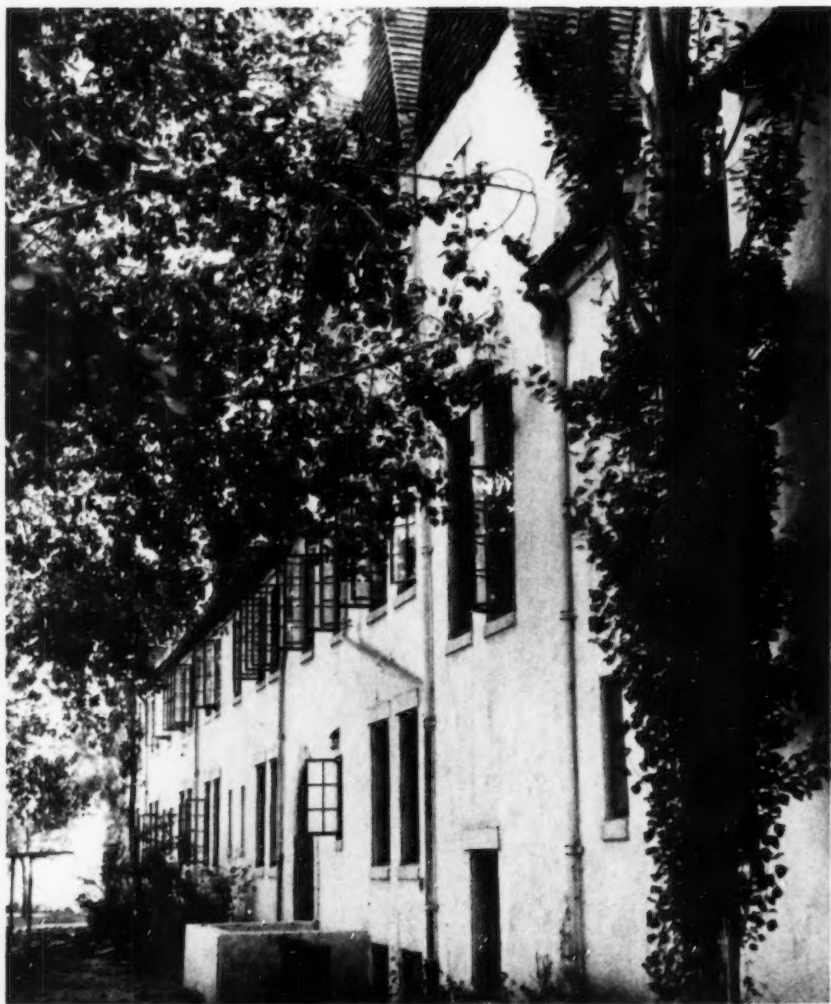
The Tehachapi State Prison for Women, built in 1932 and not designed for lateral forces, consists of a group of two story reinforced concrete buildings with steep pitched tile roofs on wood framing (Fig. 10). An exterior view of these buildings would indicate little damage except for the loss of some chimneys and some cracking, but the interiors show badly cracked tile partitions and a general shambles of the timber roof framing (Figs. 11 and 12). By the standards of present day lateral force design, the timber framing was particularly poor, using inadequate or no ties, and it is not at all surprising to see the amount of damage that occurred. Present codes, however, assign certain shear values for using tile partitions and other similar brittle elements, and on this basis the shear resistance of many partitions in the top floor would approximately meet present Uniform Building Code requirements due to the fact that these partitions were spaced quite closely to provide small rooms (Fig. 13). These partitions, however, were badly cracked (Fig. 14). This observation raises the question as to the adequacy of normal static shear tests, especially of brittle, weak materials to establish safe resistance values for earthquake loads. Present codes show an increasing tendency to permit use of these brittle materials such as plaster, plaster substitutes, hollow tile, weak deck fills, etc., as lateral force resisting elements by assigning allowable stresses for their use. At present, these values are based on static tests, and observations indicate that their performance in actual construction may not meet these expectations.

Fig. 10 Tehachapi State Prison for Women. Exterior view of typical building.

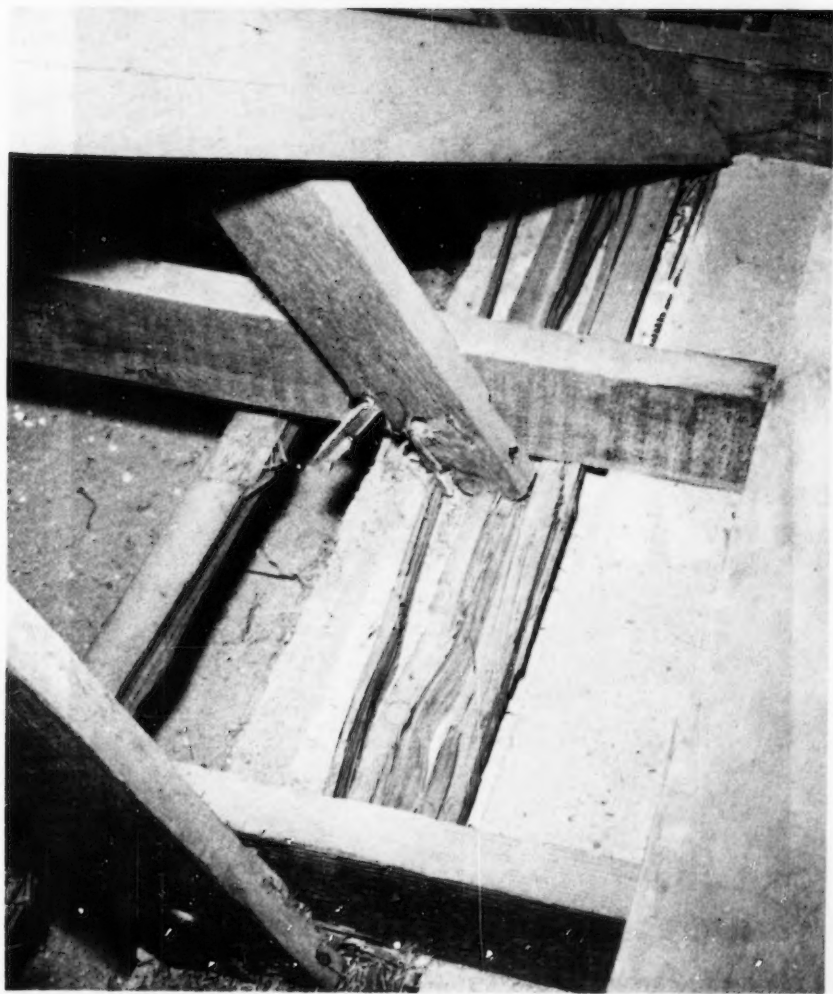
The performance of these buildings particularly illustrates the necessity of properly tying together various building elements. Where certain key connections are weak, as were the wood to concrete connections in this case, their failure permits a battering action to occur that invariably causes considerable damage. It would have cost very little to make these buildings adequately earthquake resistant by a more judicious choice of construction materials, supervision of field construction, and most important of all, by an adequate engineering design that would result in the building acting as a unit. Without these three necessities, I doubt that high earthquake coefficients as required by present codes, would have appreciably improved the performance of these buildings.

Fig. 11 Tehachapi State Prison. Shattering of wood plate in roof framing due to earthquake forces from heavy tile roof.

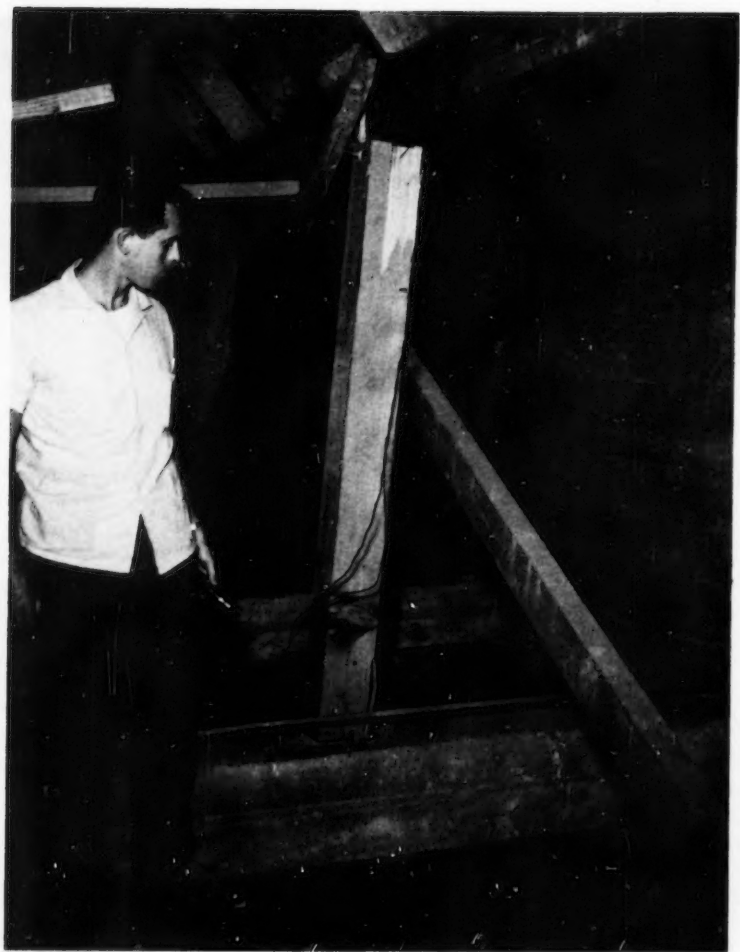
Fig. 12 Tehachapi State Prison. Wracking of wood roof framing due to earthquake. Wood members are poorly tied together. Only 2 - 1/2" bars can be seen extending through forty foot long crack in exterior 8" concrete wall.

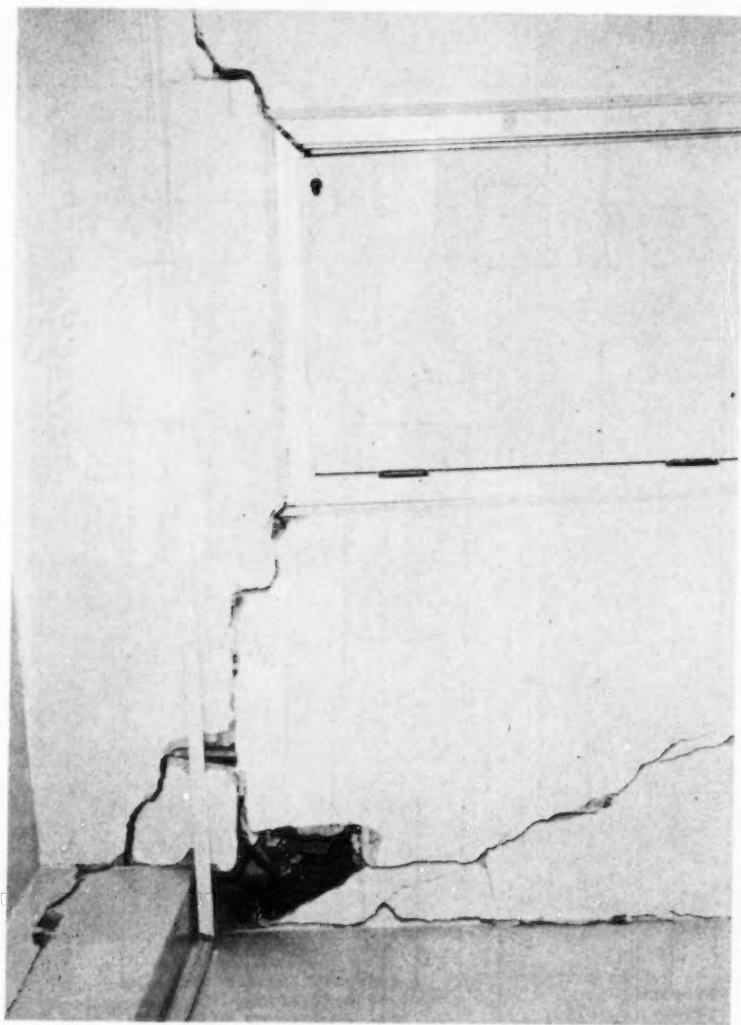
Fig. 14 Tehachapi State Prison. Interior tile partitions in top floors were badly cracked.

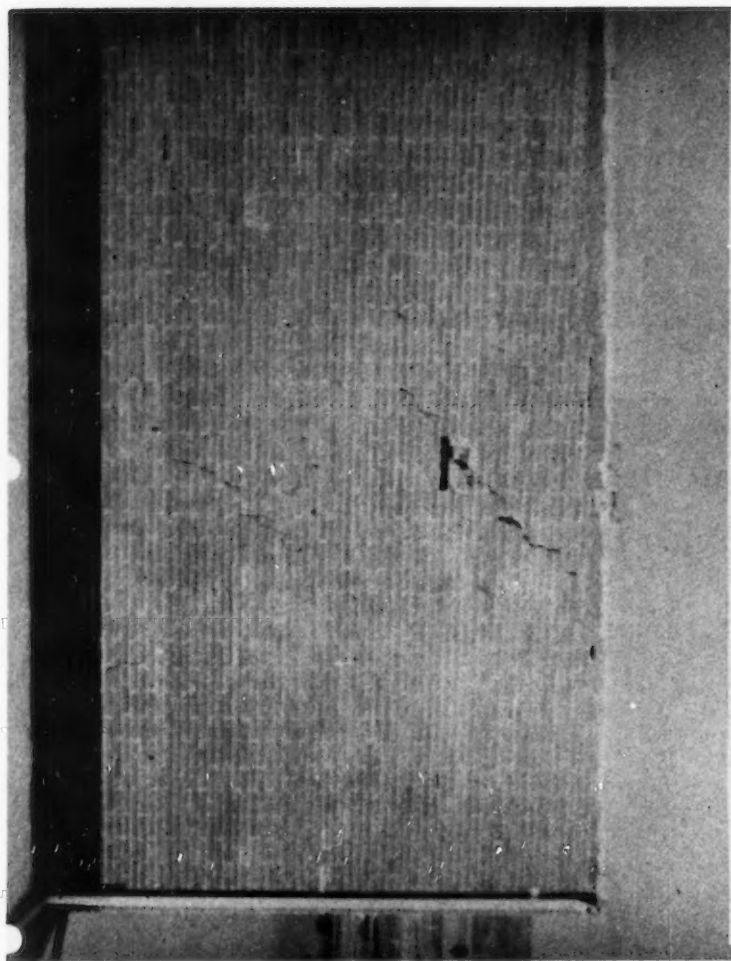
The Arvin High School (Fig. 15) is an excellent example of a building that is quite rigid, met code requirements for California Schools and, in general performed excellently. This large school, located comparatively close to the fault line, was evidently shaken quite severely. One shear wall suffered some damage by cracking (Fig. 16). This wall was constructed of grouted brick masonry, and according to code standards, was not highly stressed. However, field examination and later core samples indicated that the workmanship on this wall was poor, resulting in voids in the grout and inadequate bond to the reinforcing steel. The aftershocks of the earthquake caused this crack to

open somewhat and the loss of rigidity then permitted interior partition damage in this portion of the building.

Fig. 16. Arvin High School. This grouted brick shear wall suffered a $\frac{1}{4}$ " wide crack. Calculated shear stresses were low but the quality of workmanship on this wall was questionable.

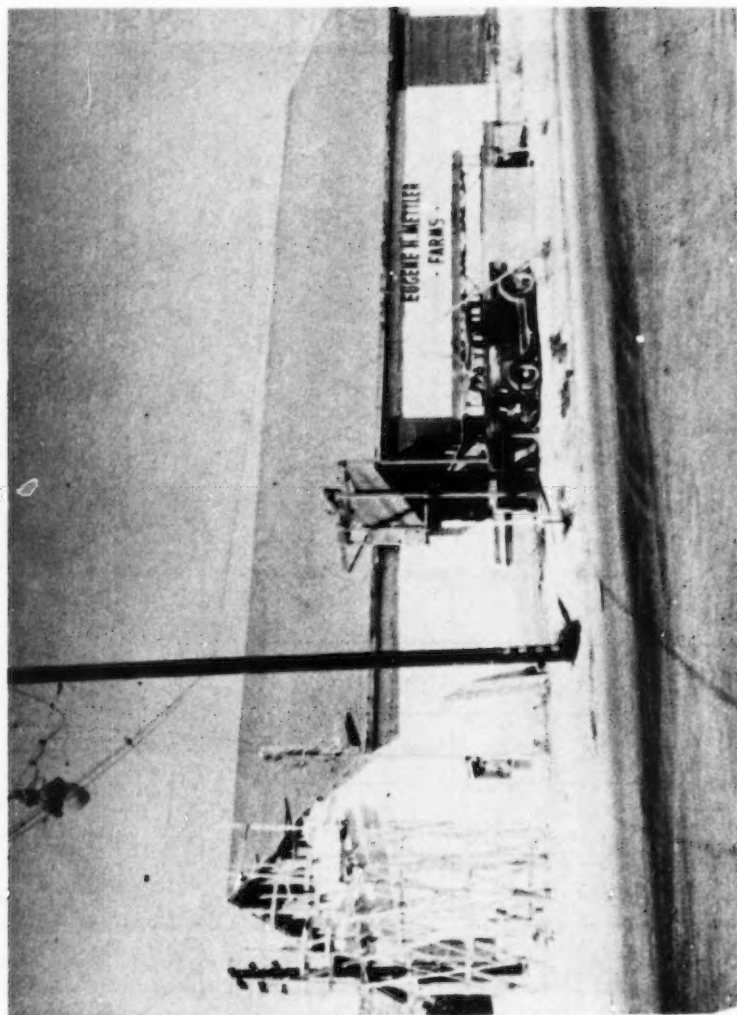
Fig. 18. Concrete block warehouse, Tehachapi.

The concrete block warehouse shown in Figure 18 is constructed of unreinforced concrete blocks with 12 x 12 reinforced concrete columns and tie beams and a wood sheathed roof on steel trusses. There evidently was no effective designed bracing, and the end wall gables were thrown out since there was absolutely no connection at the roof (Fig. 19). Beyond this, however, there was no damage. The floor was at loading platform height with the columns tied to it, so evidently the columns cantilevered above the floor and braced the building sufficiently enough for this earthquake without suffering damage. Although we could not call this a flexible building, the flexibility due to the bending of the columns undoubtedly reduced the forces exerted on the building.

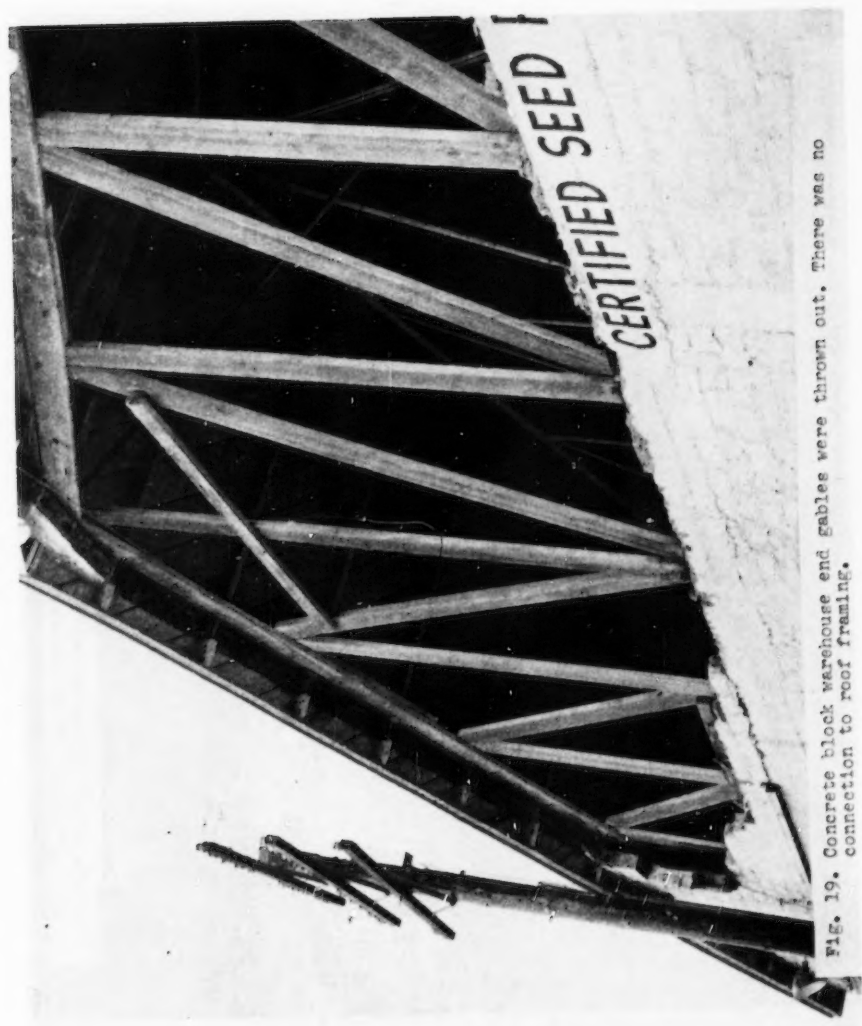
Fig. 19. Concrete block warehouse and gables were thrown out. There was no connection to roof framing.

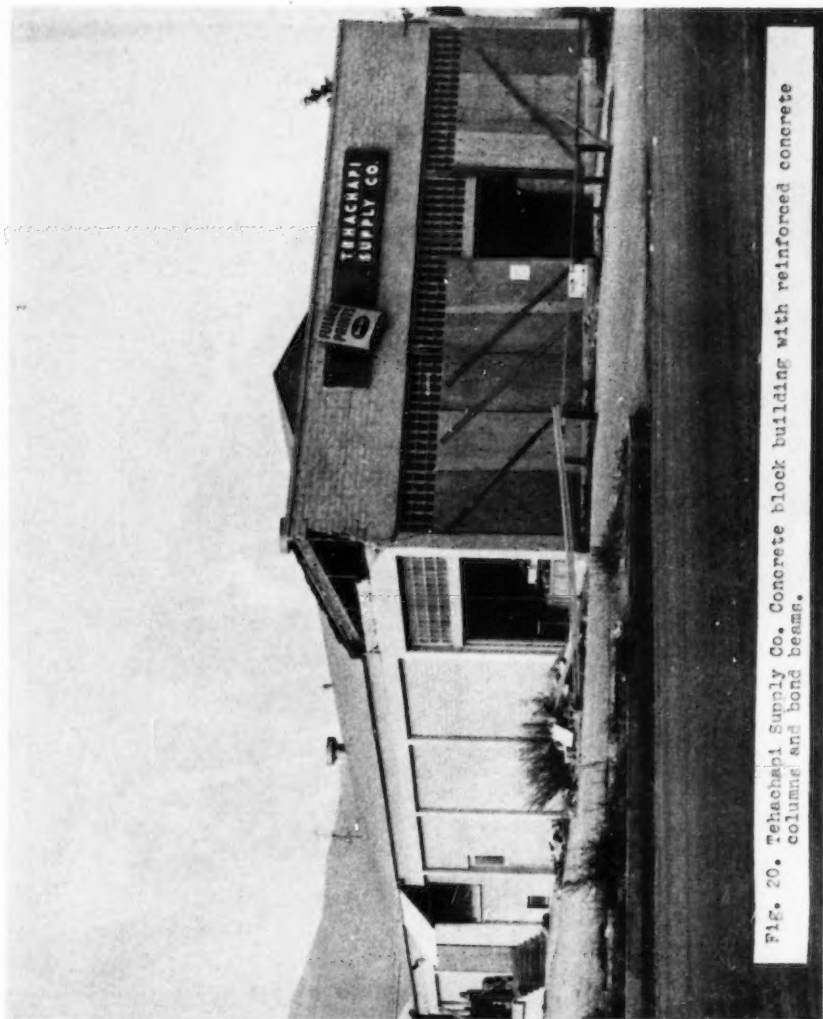
The building for the Tehachapi Supply Company (Fig. 20) was designed and built in 1946 during the material shortages. This building is 40' x 100', using concrete block walls with poured concrete columns and bond beams. Except for the first bay, which is timber, the rest is corrugated iron and there is no bracing as we ordinarily understand it (Fig. 21). However, some resistance is developed by the columns cantilevering out of the footings. At the base of the column, the dowels from the footings are 1/2" ϕ although there are 3/4" ϕ in the column. When the columns acted as cantilevers, they failed at the base (Fig. 22). There was little or no supervision of construction and changes were made from the design drawings. Dowels to parapets and bolts from wood roof to masonry were omitted while framing details were changed. As constructed, the building as a whole would "figure" for about 4%G or a 6# wind. In spite of the poor design and the poor construction due to lack of supervision, this building is usable and was open for business right after the earthquake. When the columns shattered, they permitted the building to act as a flexible structure and so prevented further damage, which could be interpreted as an interesting application of limit design. The cost of repairs for broken front windows, parapets, tops of front columns and column bases was not great to bring it back to its original condition, but it would have been expensive to bring it up to any code requirements.

FIG. 20. Tehachapi Supply Co. Concrete block building with reinforced concrete columns and bond beams.

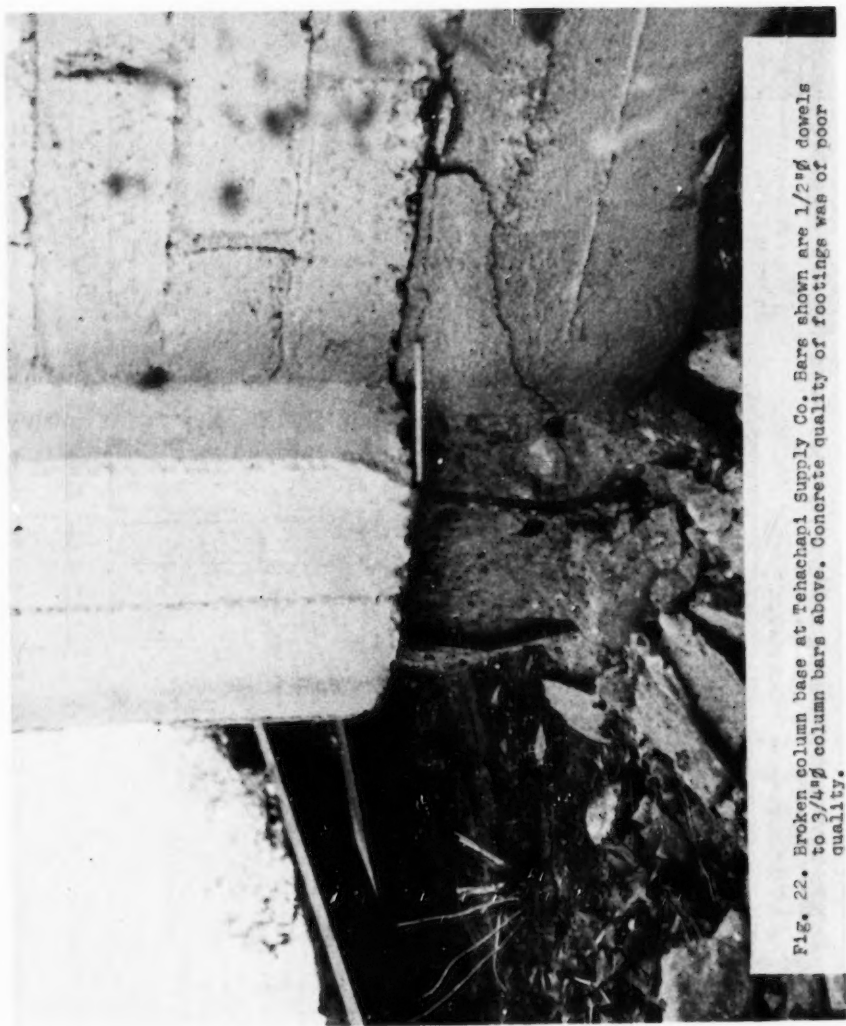
FIG. 22. Broken column base at Tehachapi Supply Co. Bars shown are $1\frac{1}{2}$ " ϕ dowels to $\frac{3}{4}$ " ϕ column bars above. Concrete quality of footings was of poor quality.

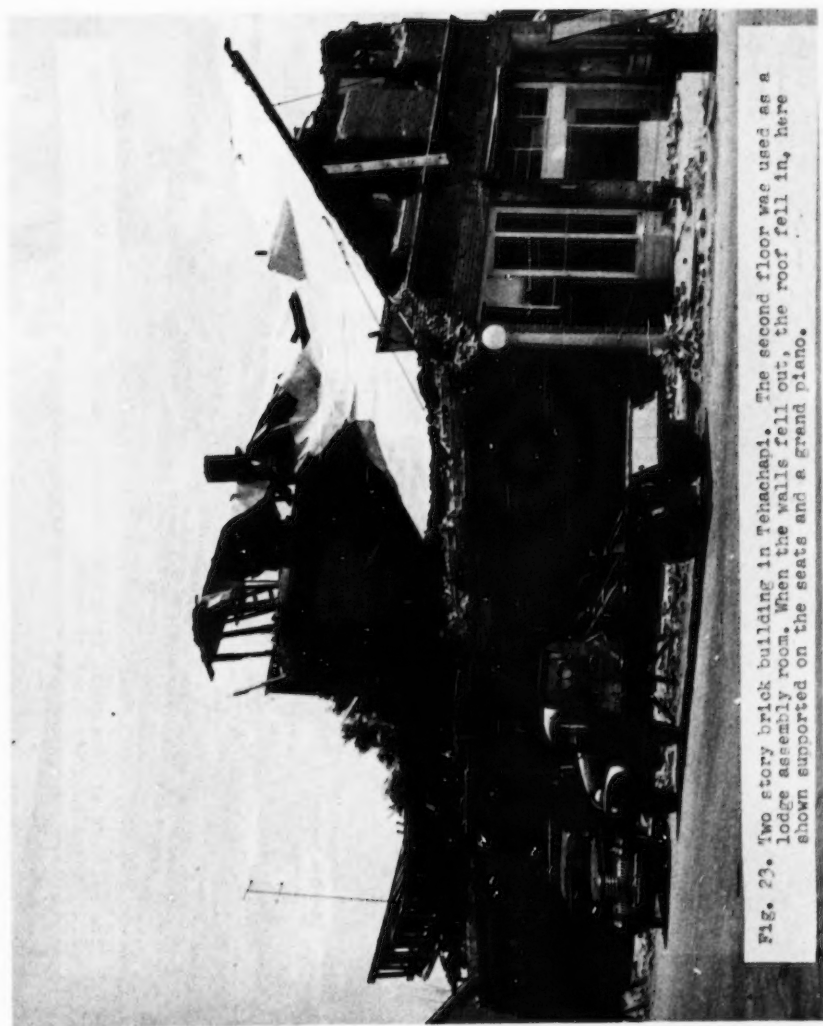
In the down town area we have an old brick building with a second floor auditorium that completely collapsed (Fig. 23). The auditorium roof is supported by the piano and seats.

FIG. 23. Two story brick building in Tehachapi. The second floor was used as a lodge assembly room. When the walls fell out, the roof fell in, here shown supported on the seats and a grand piano.

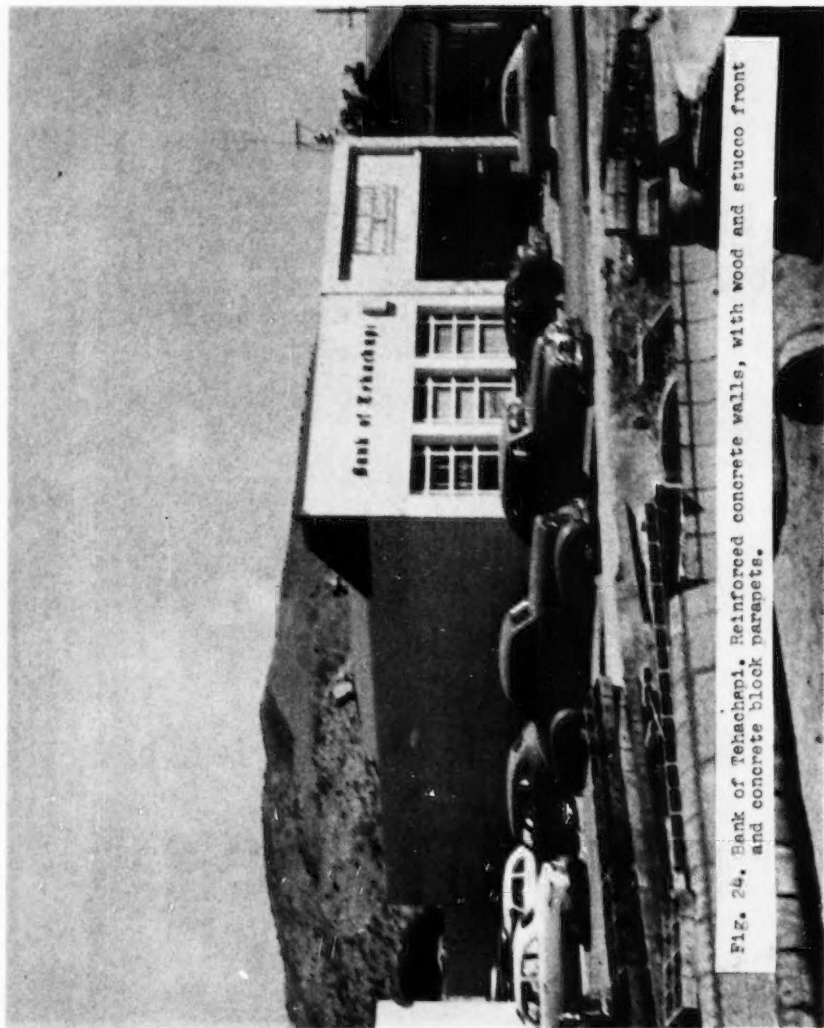
Fig. 24. Bank of Tehachapi. Reinforced concrete walls, with wood and stucco front and concrete block parapets.

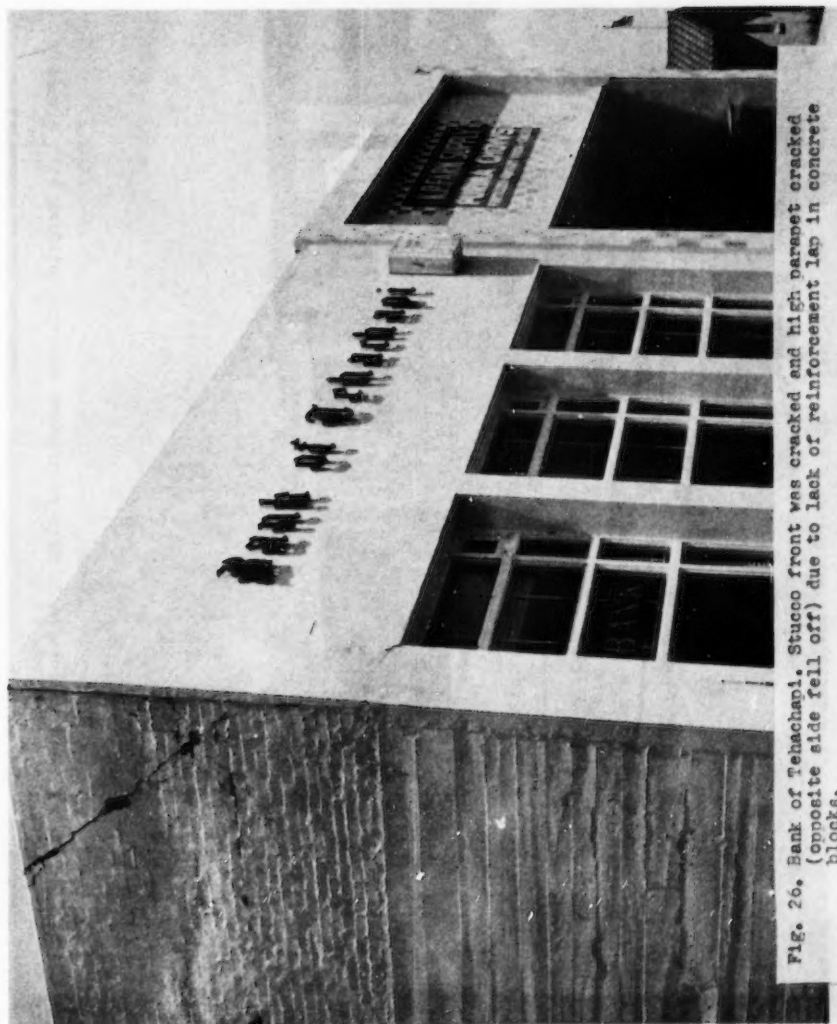
building is 56' x 73' with a long low appendage at the rear. It has 7" reinforced concrete walls with steel bowstring trusses providing a 14'-0" ceiling (Fig. 25). There was a wood roof using straight sheathing with a rod bracing system. At the rear of the bank this long appendage had a diagonal sheathed roof with no joint anchors. Based on the Uniform Building provisions, this portion had a lateral load of 200#/ft. on a 50' span, the diaphragm being 14' deep which gives an end shear of 360#/ft. The front is of wood and stucco with an inverted concrete bent taking the lateral loads. According to Uniform Building Code provisions, the rods are stressed to 37,000# per square inch with rather inefficient details for the rods. There was little damage except to the front and to the parapets which fell off (Fig. 26). Note that while the parapet was reinforced with $1/2" \text{ } \phi @ 3'-0"$, there were no dowels for the portion of the parapet that broke off.

Fig. 26. Bank of Tehachanl. Stucco front was cracked and high parapet cracked (opposite side fell off) due to lack of reinforcement lap in concrete blocks.

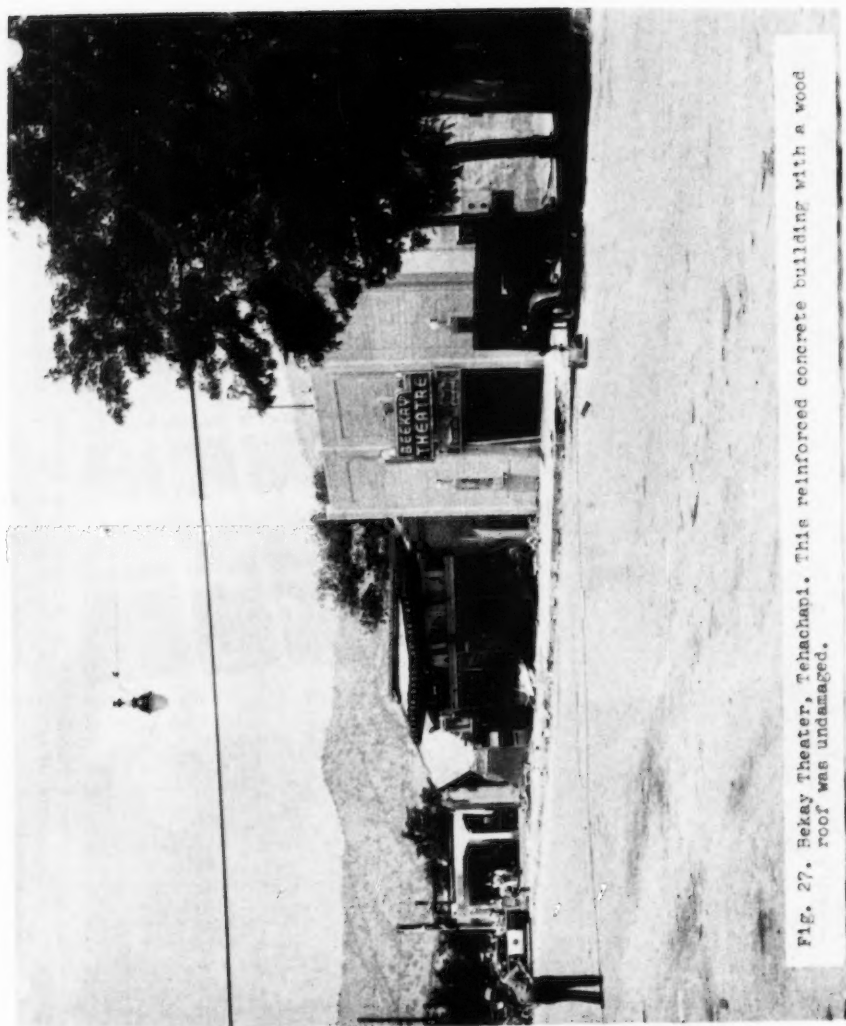
The Beekay Theater (Fig. 27) in the center of the damaged area was undamaged except for a small crack in the wall on the far side. This building is 43' x 75' with 8" reinforced concrete walls between 12 x 12 columns and bond beam (Fig. 28). These supported 3 bowstring timber roof trusses, wood purlins and straight wood sheathing. It has $5/8" \text{ } \phi$ rod bracing in the plane of the lower chord but this ends at the lobby stud wall. The so called plans of this building were very meager. For such a major building element as this wall, there was absolutely no information on the drawings and the plaster prevented a determination of the construction below the ceiling. Assuming the wall to be an adequate shear resisting element (which I personally doubt), the rod bracing is good for about 11%G on dead load only with a shear in the wall of about 350#/ft. The calculated deflection due to the rod system is about 1", assuming rods tight, and neglecting such items as bolt slip and deformations in the shear walls. The maximum permitted by one proposed formula is .8" and must include these effects.

Fig. 27. Bekay Theater, Tehachapi. This reinforced concrete building with a wood roof was undamaged.

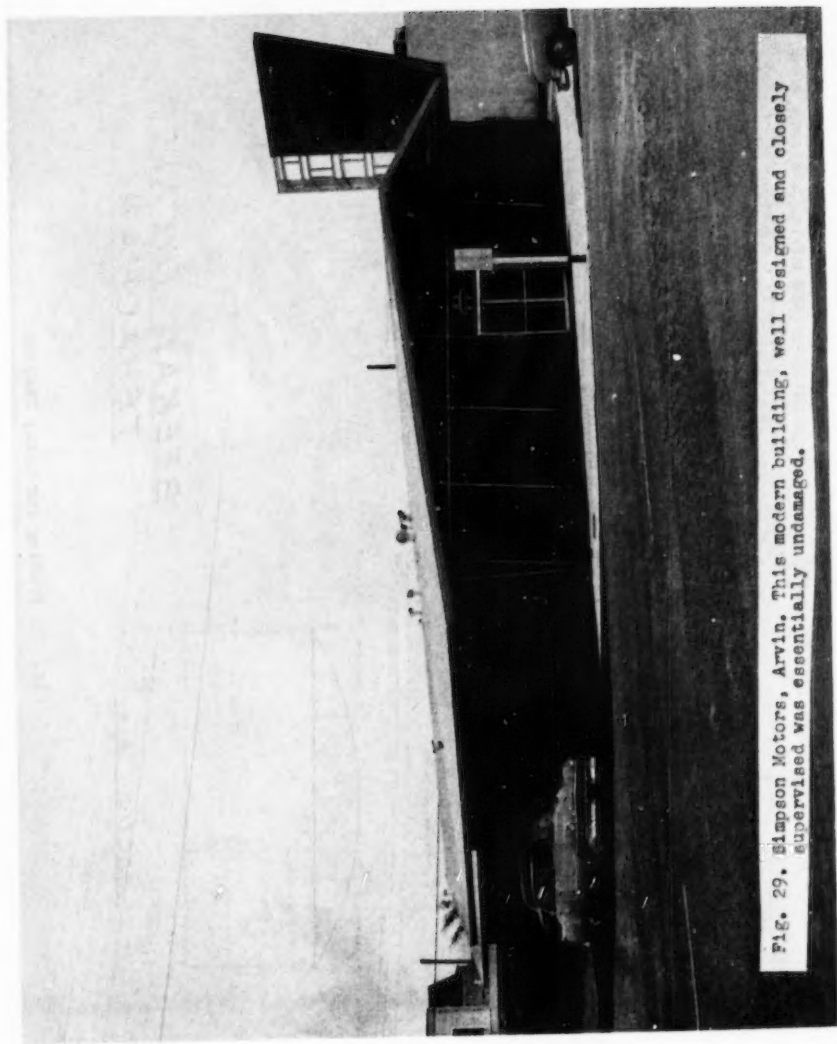
To me the most interesting building in the area was this Auto Sales Agency in Arvin (Fig. 29). Designed and closely supervised by both an architect and an engineer, it suffered the damage of only two cracked panels of glass and a small crack in the masonry over the side door. The framing (Fig. 30) is very simple, using steel beams and columns, a metal roof deck acting as a diaphragm, and unreinforced concrete block walls as resisting elements. However, all the basic elements of lateral force resistance are present and the structure is well tied together, and the results achieved were outstanding, proving that this type of modern architectural design can be made safe for earthquakes.

Fig. 29. Simpson Motors, Arvin. This modern building, well designed and closely supervised was essentially undamaged.
